Windows 7 could not load the FTDI VCP driver for aMG_USBConverter-N

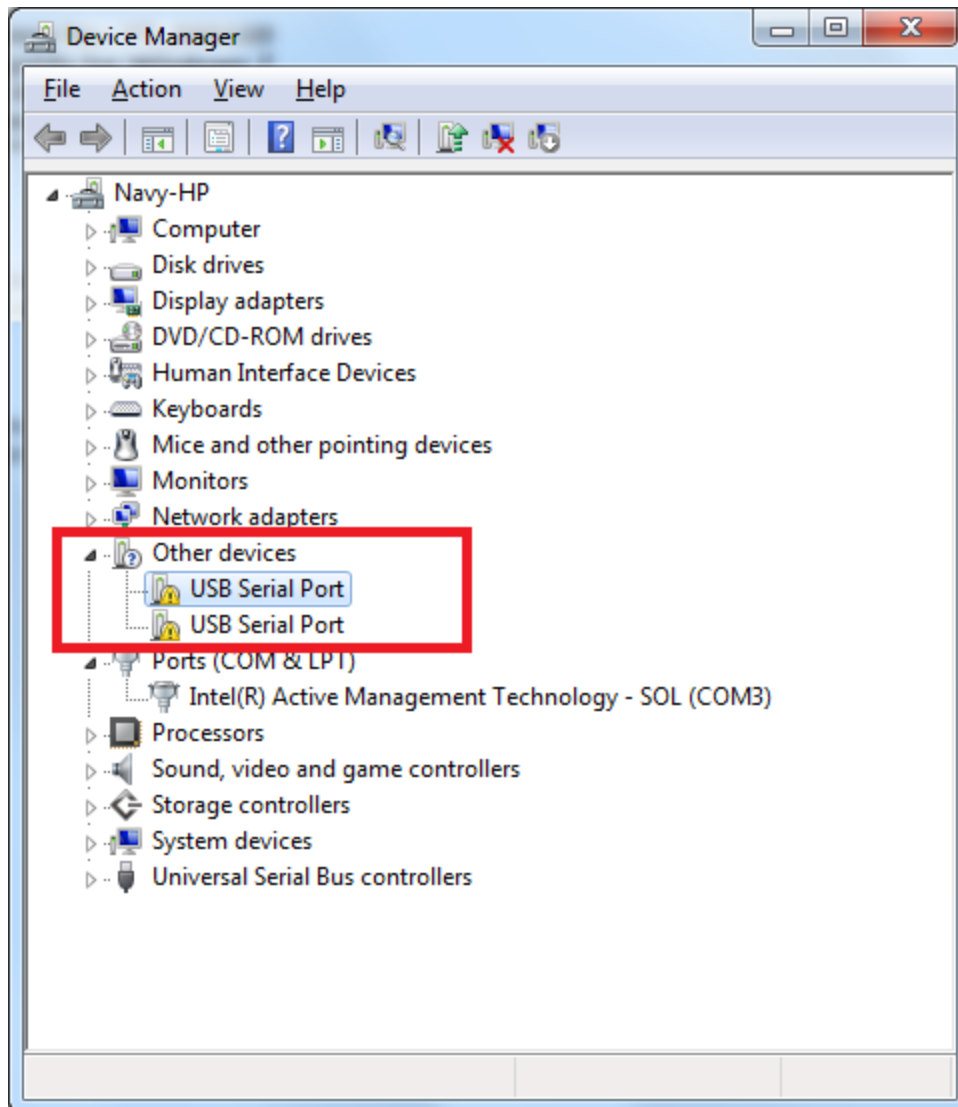
Windows 7 could not find the driver for the device for aMG_USBConverter_N when plugin to the board the USB port.

Error above exist after install the VCP driver by chip manufacturer (FTDI).
